Re: Notice of Violation
Compliance Evaluation Inspection
EPA I.D. No.: MND 000 824 029

COMPLIANCE EVALUATION INSPECTION REPORT

FACILITY NAME: 3M – St. Paul Tape Plant

DATE OF INSPECTION: October 22, 2003

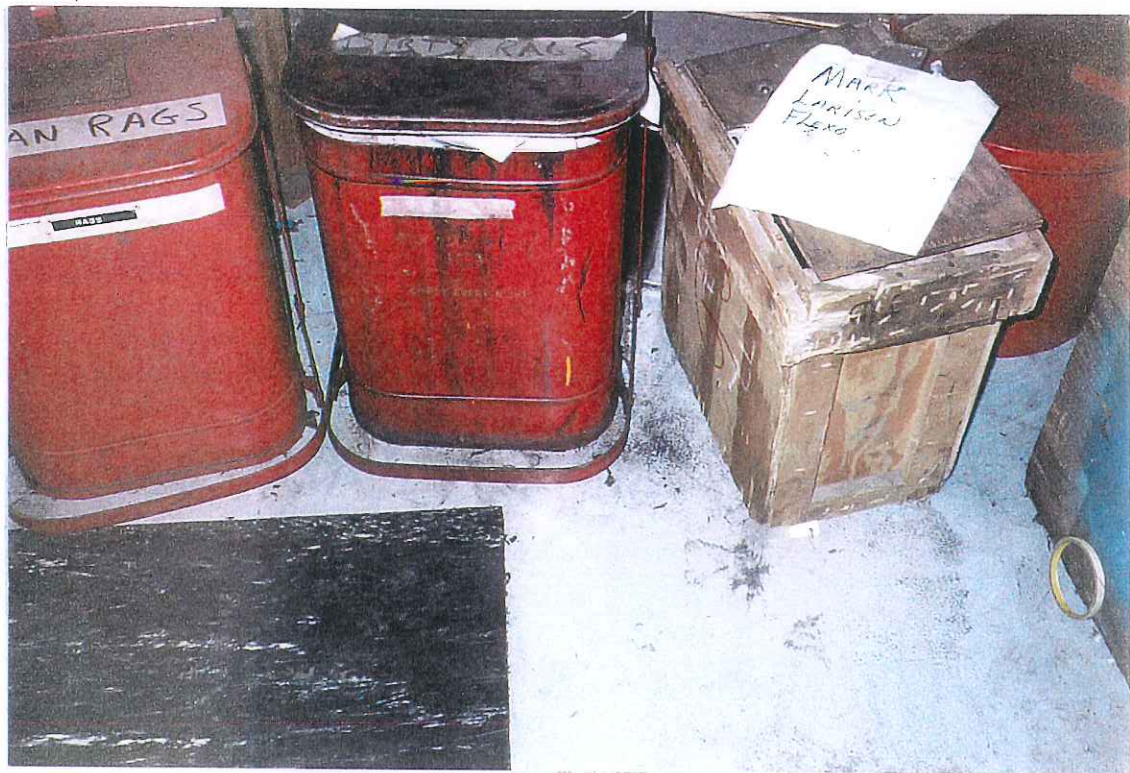
We proceeded first to Bldg # 20, Floor 4F, the Knife Set-up Room. We first observed a SAA container (approx 5-8 gallon capacity) which contained used rags. It had a spring-loaded lid, activated by a floor level bar. The container did not include a HAZARDOUS WASTE label, and the lid was not closed entirely, leaving a gap of less than 1" with the top of the container. (Photo # 1).

Photo No: 1 **Date:** 10/22/03 1:42 pm **Site:** 3M (Bush Avenue)
Description: SAA container in center (used rags). No HW label. Lid not entirely closed. Clean rags container to left of photo. Bldg 20, Floor 4F, Knife Set-up Room.

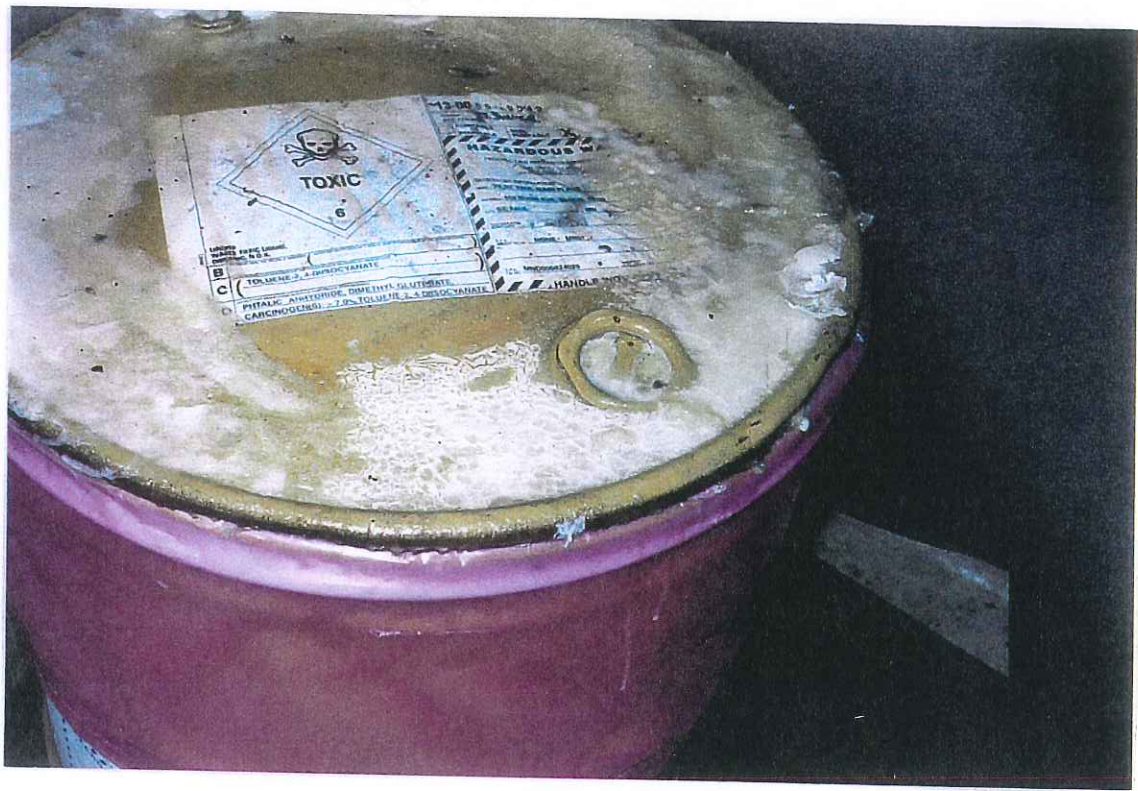
We observed another 55-gallon drum in 5F's TDI Room. It was affixed with a HAZARDOUS WASTE label, and dated 9/29/03. The drum was plastic-lined. Its contents were marked as TDI. A solid residue was observed on the lid of the drum. (Photos # 5 and # 6).

Photo No: 5 **Date:** 10/22/03 2:19 pm **Site:** 3M (Bush Avenue)
Description: 55-gallon SAA drum. Contents: TDI. Dated 9/29/03. Solidified material accumulated on lid. Bldg 20, Floor 5F, TDI Room.

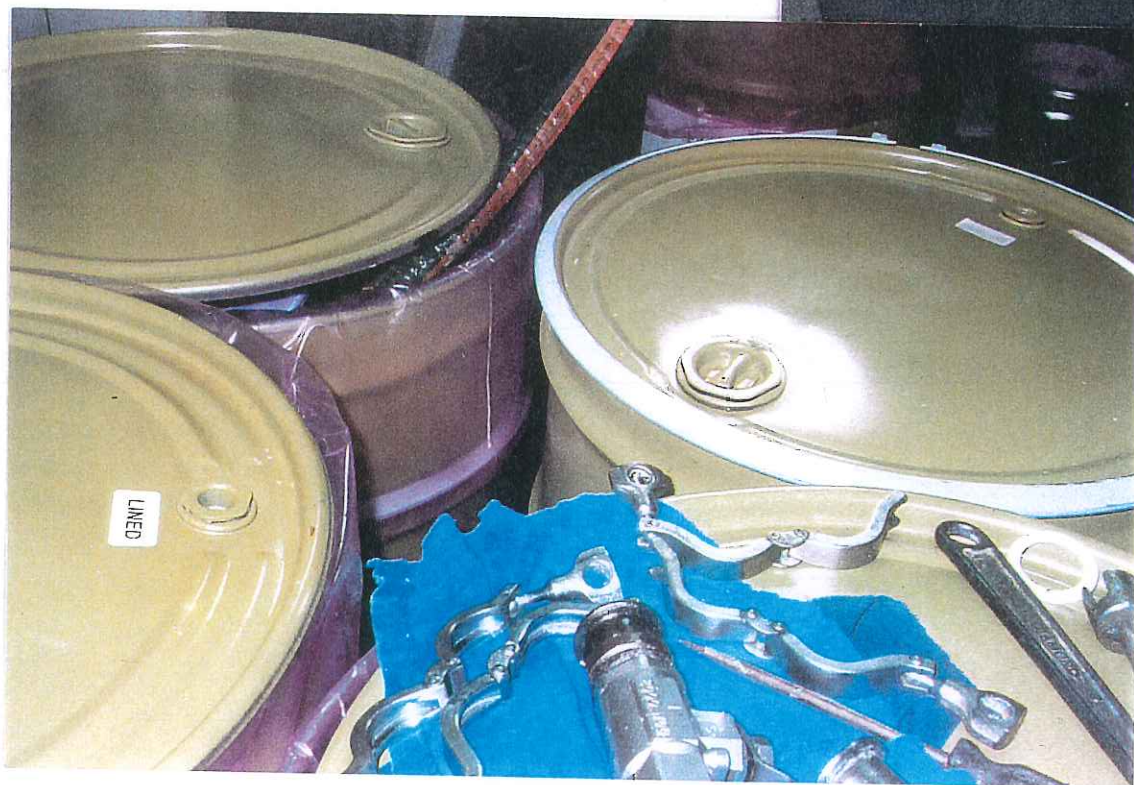
Nearby in the TDI Room we observed a pallet upon which rested four (4) 55-gallon steel drums. Each drum was affixed with a HAZARDOUS WASTE label, and dated 10/17/03. Each drum's contents were TDI. One drum was observed to have a hose (roughly 1" - 2" diameter) inserted in it, resting beneath the lid in such a way as to render the drum opened.⁵ (Photos # 8 and # 9.)

⁵It is the opinion of the author that the bung diameter was sufficient to have allowed the flexible hose to be inserted through it, rather than to have the hose placed beneath the lid, between the lid and the rim of the drum, which, in effect, left the drum open and susceptible to its contents being spilled.

Photo No: 8 **Date:** 10/22/03 2:22 pm **Site:** 3M (Bush Avenue)
Description: 4 55-gallon SAA drums. Contents: TDI. Dated 10/17/03. Drum to rear, left is open w/ flexible hose inserted. Bldg 20, Floor 5F, TDI Room.

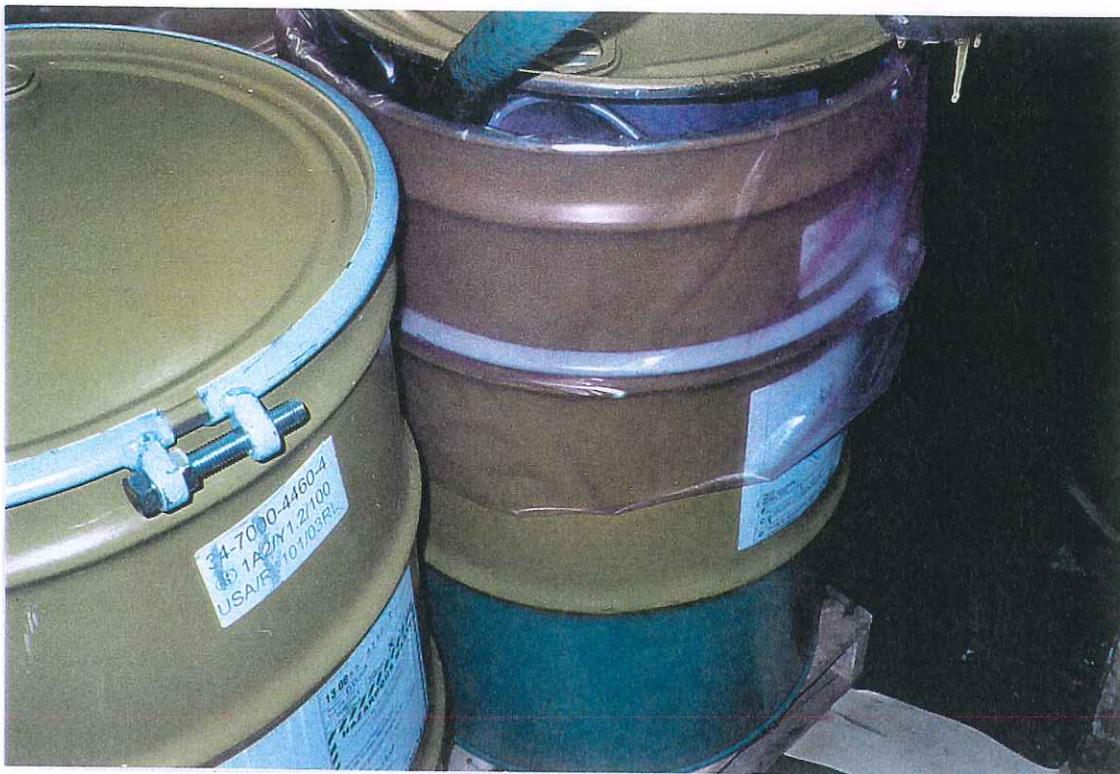
Photo No: 9 **Date:** 10/22/03 2:22 pm **Site:** 3M (Bush Avenue)
Description: 4 55-gallon SAA drums. Contents: TDI. Dated 10/17/03. Drum in center of photo is open w/ flexible hose inserted. Bldg 20, Floor 5F, TDI Room.

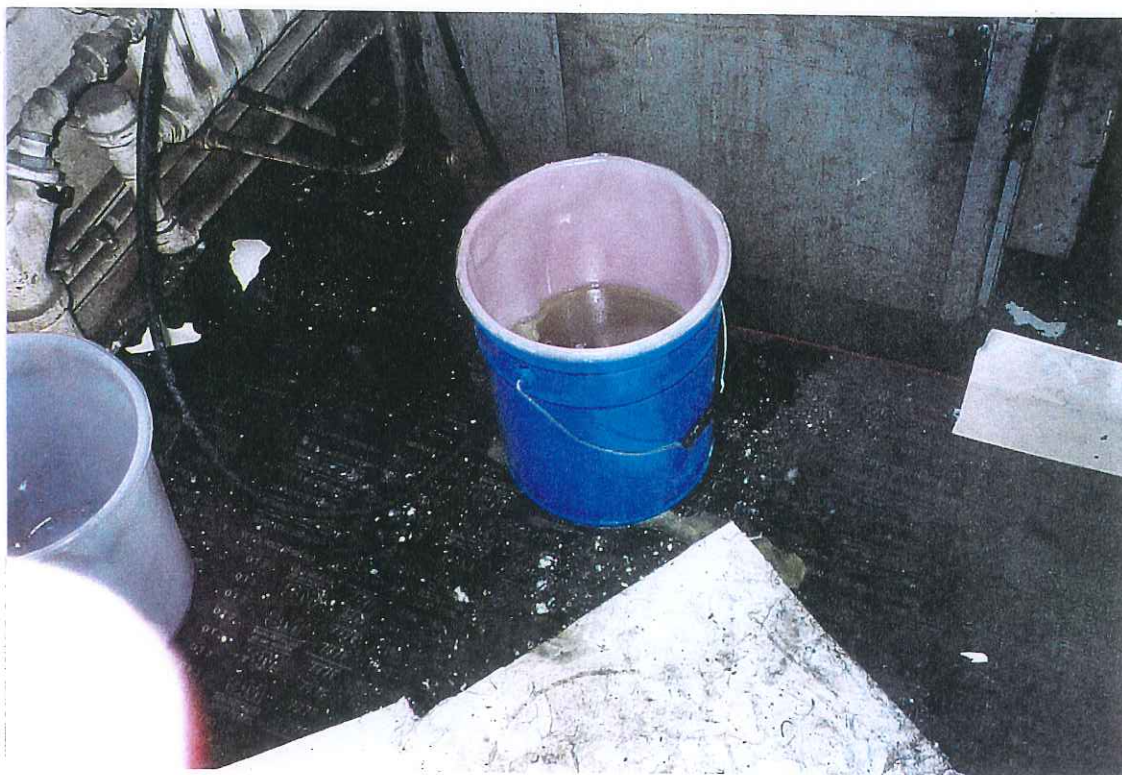
Also in the TDI Room, we observed a blue 5-gallon plastic-lined container situated on the floor. The container was open and unlabeled. It was located adjacent to the TDI pump. Its contents were TDI in an ammonia-alcohol solution. 3M stated, subsequent to the inspection, that the open container held a flammable liquid used for neutralizing un-reacted TDI.⁶ (Photo # 10.)

Photo No: 10 **Date:** 10/22/03 2:24 pm **Site:** 3M (Bush Avenue)
Description: 5-gallon SAA container. Contents: TDI/ammonia-alcohol solution. Container is open; unlabeled. Bldg 20, Floor 5F, TDI Room.

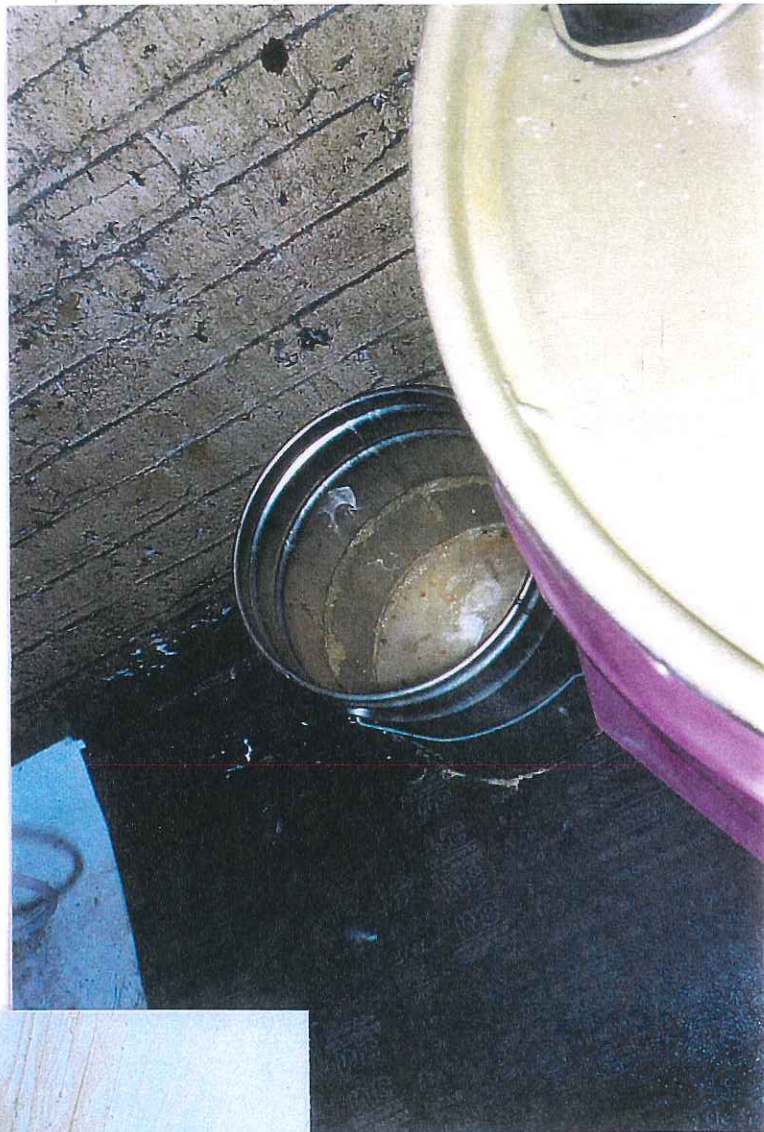
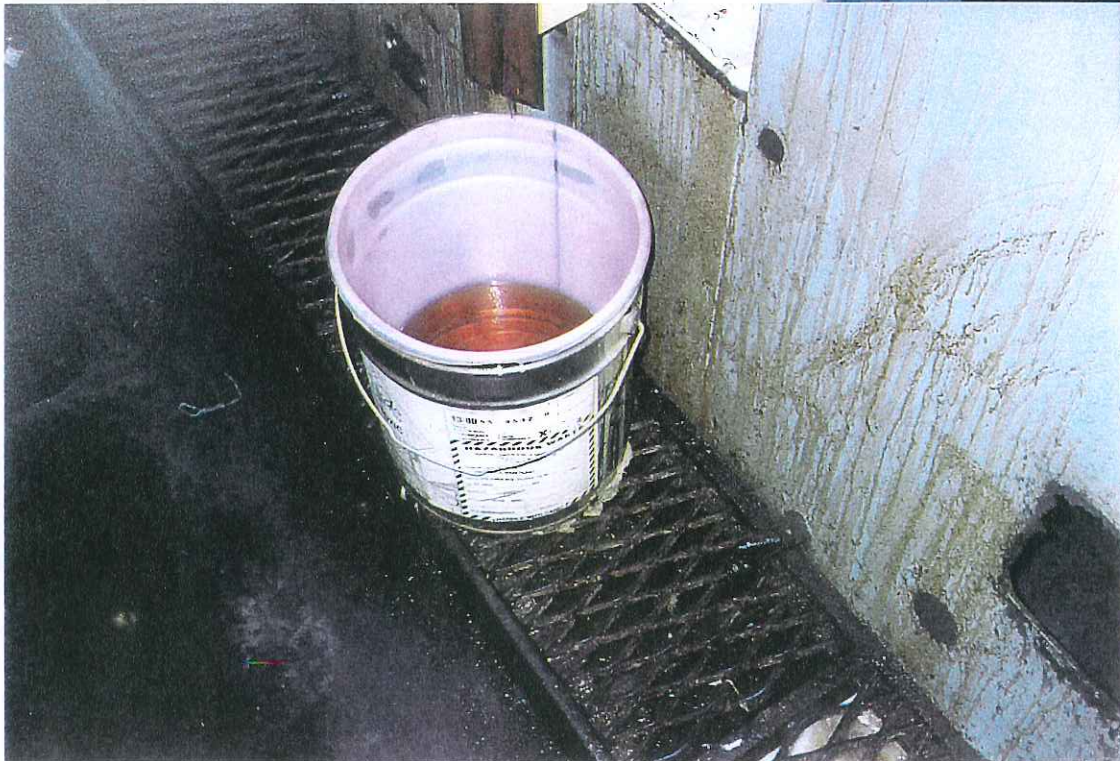
Situated in the center of the TDI Room, on top of a wrought iron grate bolted into the base of a processing machine, we observed an open 5-gallon container. The container was affixed with a HAZARDOUS WASTE label, but the label did not identify the contents therein. Initially, I was told it contained either TDI or diester. I observed and photographed a hardened residue on the outside of the container. (Photos # 12 and # 13.) Although the contents of the container were not stated on the label, the label did identify the waste code as MN01.⁸ (See Photo # 13, bottom center of photo, on line identified as EPA WASTE CODE, just above the facility U.S. EPA ID no.) At the time of the inspection, 3M's Chris Cox, who is employed in the TDI Room, informed me that the contents were diester. In its April 30, 2004 response to U.S. EPA's April 6, 2004 Request for Information, 3M stated that the container's contents were diester, "a non-regulated raw material."⁹

Photo No: 12 **Date:** 10/22/03 2:29 pm **Site:** 3M (Bush Avenue)
Description: 5-gallon SAA container. Contents: TDI or diester. Container is open; unlabeled. Hardened residue on outside of container. Bldg 20, Floor 5F, TDI Room.

Photo No: 13
Date: 10/22/03 2:29 pm
Site: 3M (Bush Avenue)
Description: 5-gallon SAA container. Contents: TDI or diester. Container is open; unlabeled. Hardened residue on outside of container.
Bldg 20, Floor 5F, TDI Room.

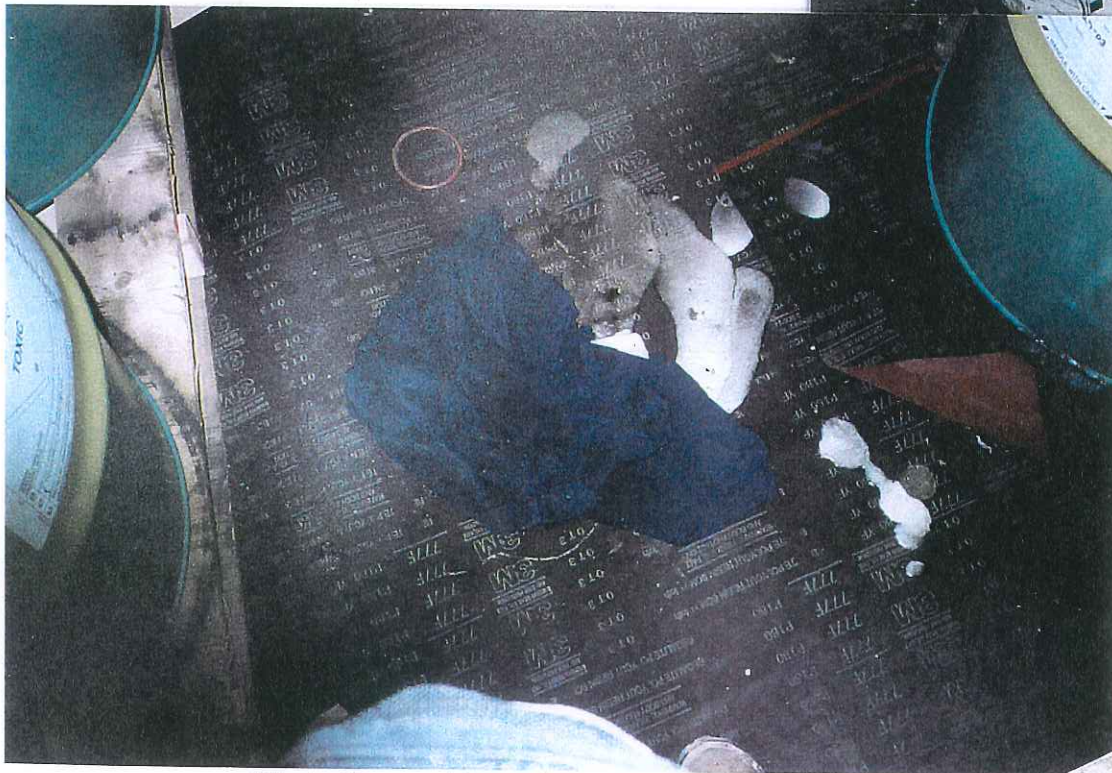
We observed a spill of a hardened material in the center of the TDI Room. The spill encompassed approximately one-square foot in area. There was a spattering of the same material in several locations, each of which was several inches in diameter, in proximity to the larger spill. The material was solidified, apparently waxy and milk-colored. 3M employees informed me at the time of the CEI that the material was a urethane which contained TDI. Underlying the spill was a cardboard-like paper. A used rag covered part of the spill. (Photo # 14.) In its April 30, 2004 letter, 3M confirmed that the material was a urethane resin which was assigned the waste system profile of 13-0055-9542-9, the same waste code assigned to TDI.¹⁰

Photo No: 14 **Date:** 10/22/03 2:42 pm **Site:** 3M (Bush Avenue)
Description: Spill on floor. Urethane containing TDI. Bldg 20, Floor 5F, TDI Room.

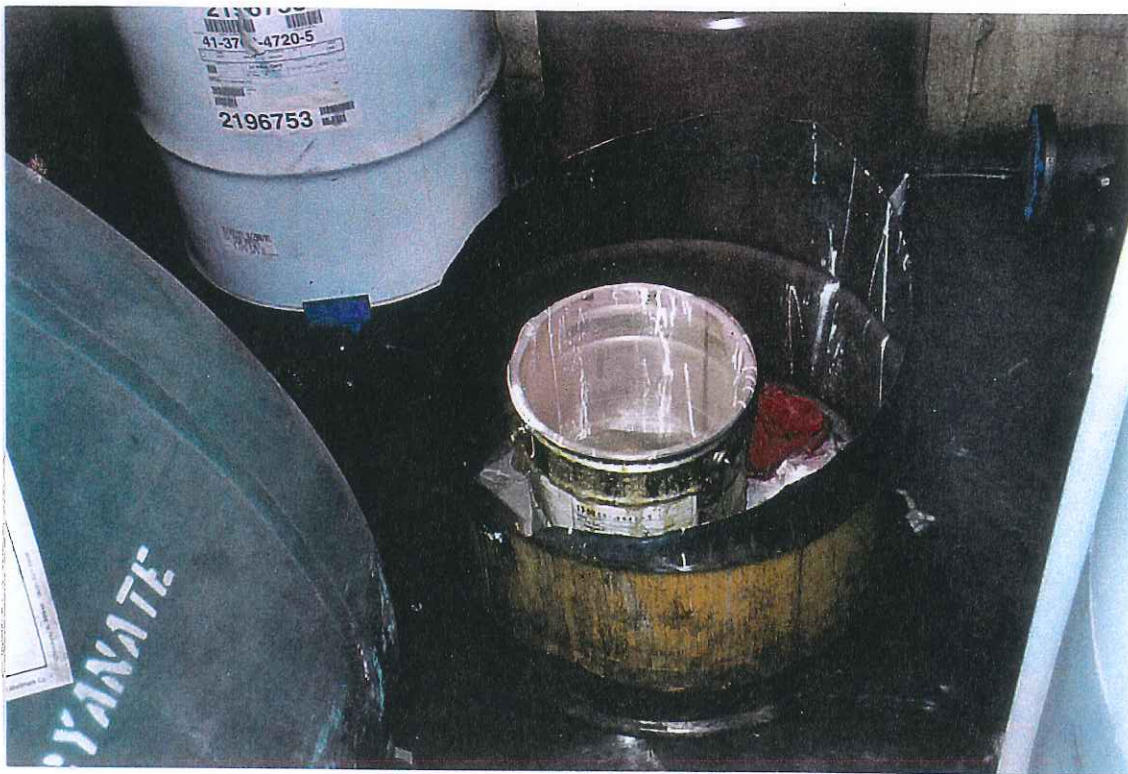
We next observed a 5-gallon container which was situated inside a sheered-off 55-gallon steel drum (such that approximately the lower 1/3 of the drum remained) was in the same general area of the facility as that identified in Request No. 7 above. (See Photo # 15.) The smaller container was affixed with a "HAZARDOUS WASTE" label that was partially covered over with a hardened, yellow residue. The 5-gallon container was lined with a plastic liner. At the time of the inspection, the contents of the 5-gallon container were unknown. In its April 30, 2004 letter, 3M does not state the contents of the container but does identify its waste profile as being 13-0055-9542-9. The contents of the container would therefore include TDI.¹¹

Photo No: 15 **Date:** 10/22/03 2:43 pm **Site:** 3M (Bush Avenue)
Description: 5-gallon SAA container. Contents: unknown. Container is open.
 Hardened residue on outside of container. Bldg 20, Floor 5F, TDI Room.

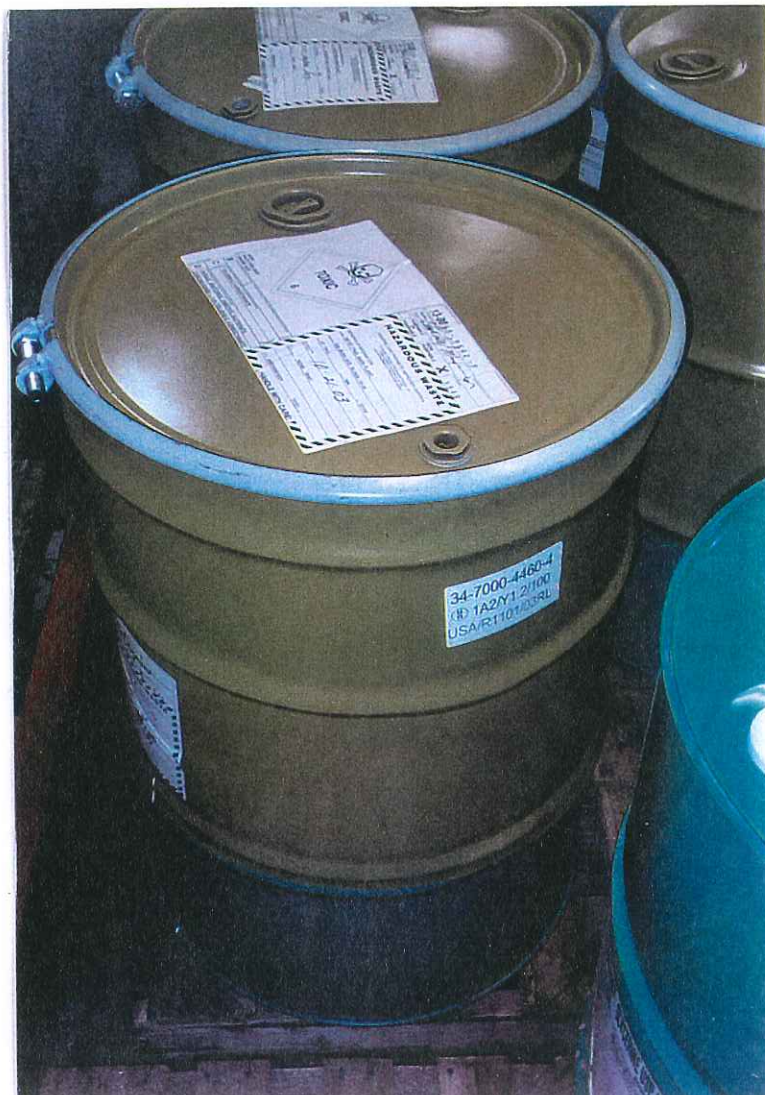
Photo No: 16
Date: 10/22/03 2:45 pm
Site: 3M (Bush Avenue)
Description: 55-gallon TDI drums. Labeled and closed. Awaiting shipment.
 Bldg 20, 1st Floor, 90-Day Area.

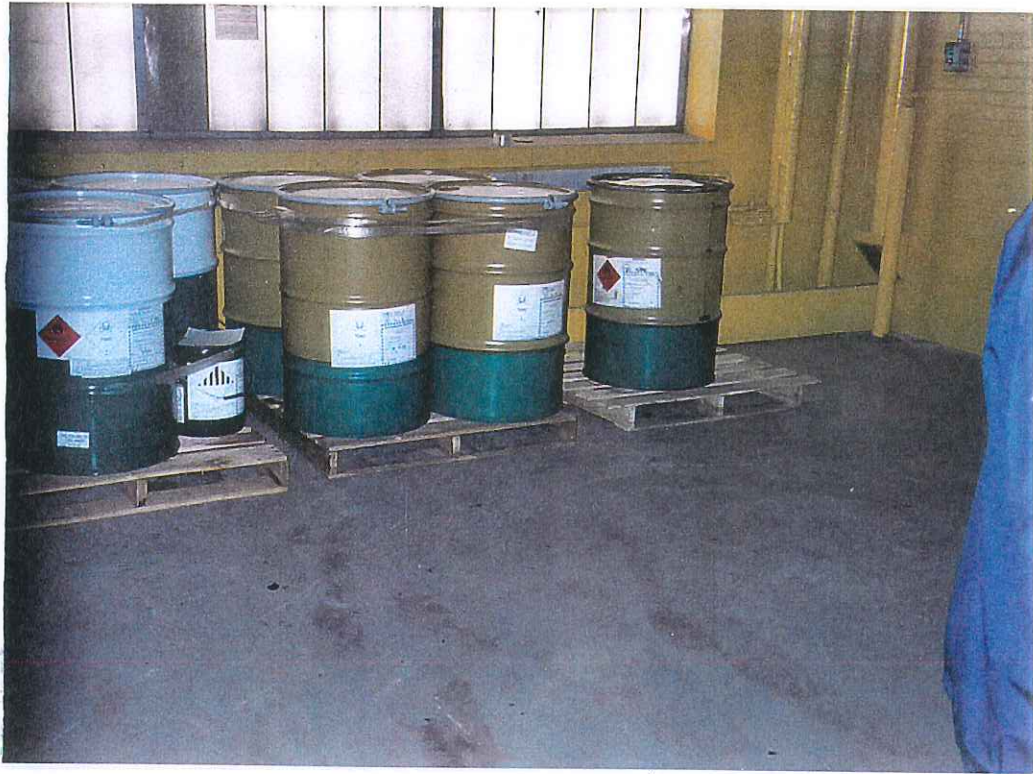
Photo No: 17 **Date:** 10/22/03 2:59 pm **Site:** 3M (Bush Avenue)
Description: 55-gallon TDI drums. Labeled and closed. Awaiting shipment.
Bldg 20, 1st Floor, 90-Day Area.
